Garden Bay Sailing Club

newsletter

October
2021

Poop Deck

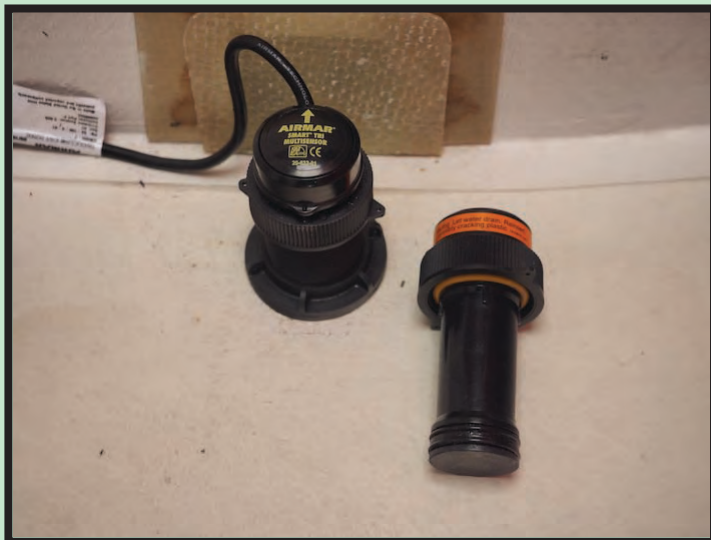
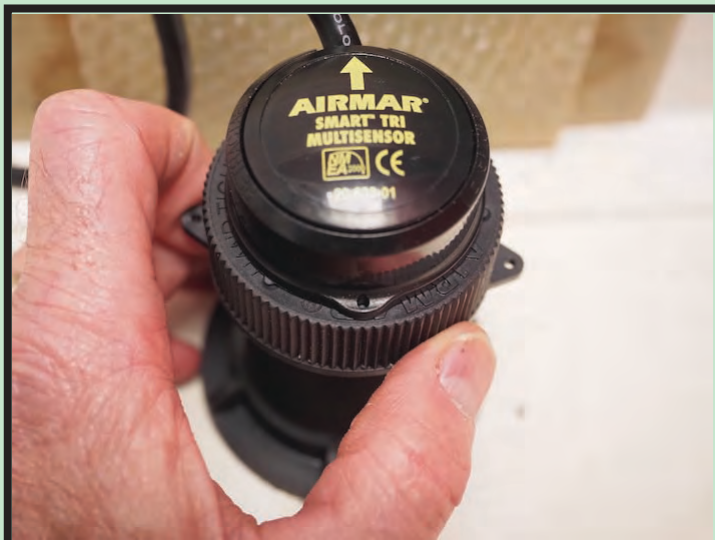
Have on hand the blanking plug that will replace the sending unit in the housing while the speedometer is out for cleaning. This will have been supplied along with the sending unit from the factory. I like to have a rag handy that can be held over the housing when the sending unit is first removed. Have a good look at the blanking plug before starting the job to ensure the two O-rings which provide the seal are not damaged and then give them a light coating of silicone lubricant or petroleum jelly to ensure a good seal.

There may be a light safety wire strung through the insert, the cap and the housing – this can be removed now.

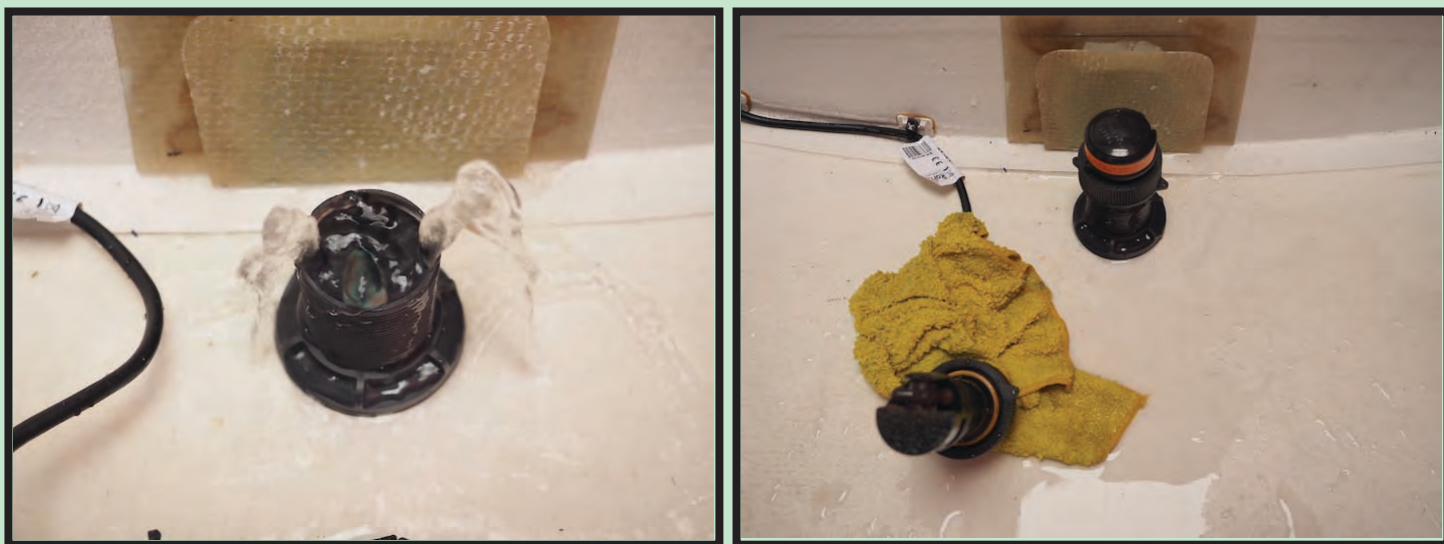
Turn the cap screw on the sending unit counter clockwise till fully loose. The last few turns also acts a jack to start lifting the sending unit in the housing. No water will flow just yet! Have the rag handy or if you prefer, the blanking plug to staunch the inflow of water and remove the sending unit from the housing by pulling straight up. A little back and forth twist is sometimes needed if the unit has been in the housing for a while. Some housings have been designed with a flapper valve that flips closed under the flow of water.....

....entering the boat as the sending unit is removed. This does not provide a perfect seal and some water will still flow into the boat. Replace the sending unit with the stopper plug and screw the cap nut down finger tight.

Have a look at the paddle wheel and combined depth/temperature head. The paddle wheel will likely have some growth that is preventing an easy spinning of the wheel. Clean carefully around the wheel being conscious of not pushing or prying hard enough to bend the axle of the paddle wheel. If that does happen, a replacement wheel and axle can be ordered from the manufacturer. If the unit is covered in barnacles a ten minute dip of the head in a bowl of vinegar should make cleaning easier. Be sure to clear between the housing and the tip of the paddles as this is where the sensor is located to pick up the signal from the spinning wheel. Here is the advantage of doing this job from inside the boat as there is better access and control for cleaning the unit than a diver can hope to achieve. Clean with a scotch pad or scrape the flat surface being cautious of scratching the sensor head over the depth/temperature surface.

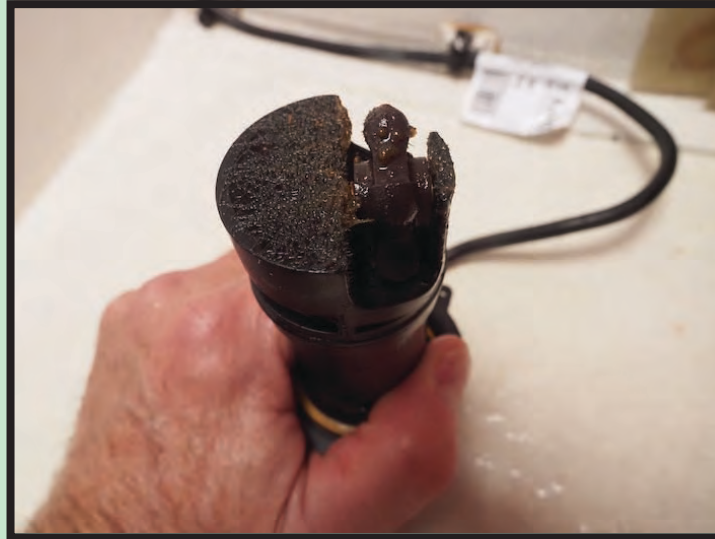
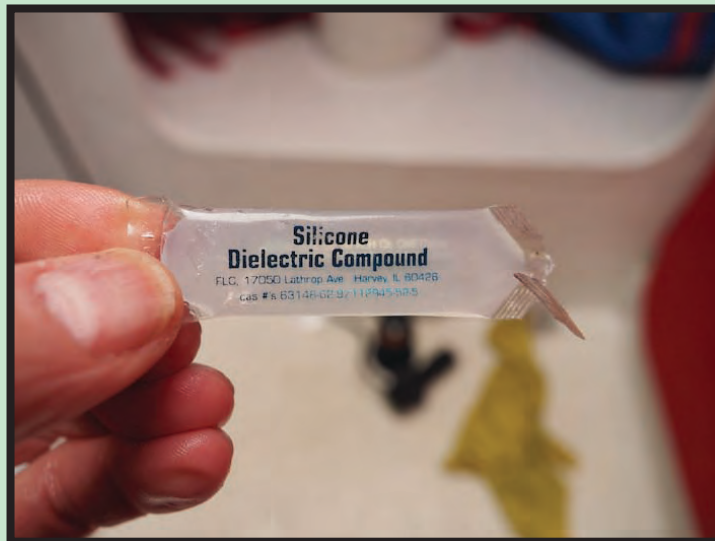
After cleaning the sending unit, inspect the O-rings – one near the bottom of the unit and one up under the cap nut. The O-rings must be must be intact and well lubricated to make a watertight seal. Unscrew the cap nut on the blanking plug and remove the plug from the housing. Make a note of the arrow on top of the sending unit – it must point toward the bow of the boat. Slide the sending unit into the housing aligning the arrow with the bow. Screw the cap several turns until the threads are engaged. Turn the cap nut finger tight while ensuring the arrow remains pointing forward. Re-install the safety wire if using one and return the.....

....blanking plug to storage. Mop up the water and you are finished!
